Manhole Inspection Summary

Manhole # S65I__014MH

Insp Date: **2/5/08 1:31 PM**

Location Address: **550 Dundalk Ave.**

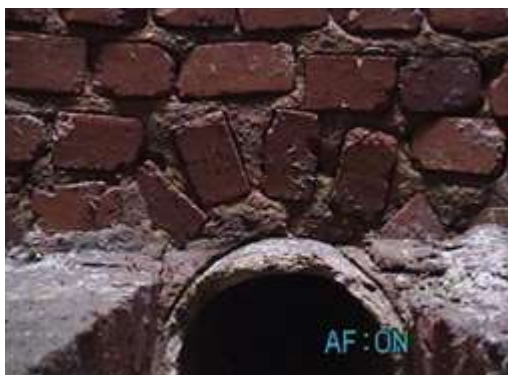
Defect 4

Cracked pipe seal I12

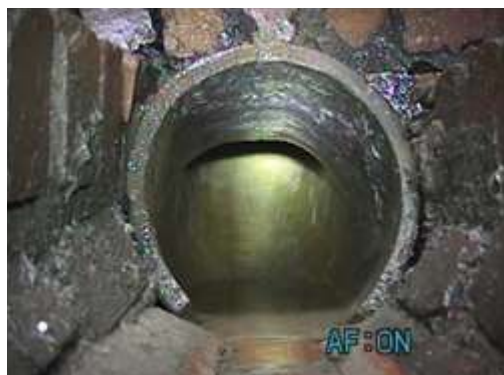
Defect 3

Broken pipe 5:00-7:00 I6.

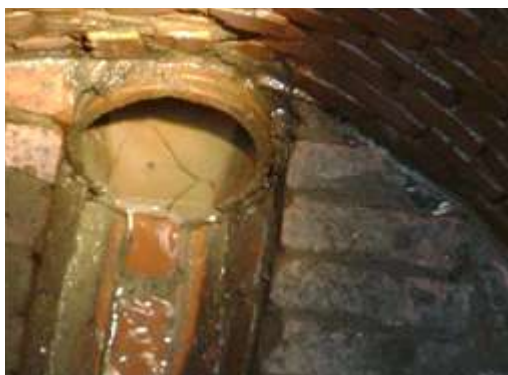
Defect 5

Comments **FRACTURE MULTIPLE 5:00-7:00 I6 AT BOTTOM OF DROP INVERT. INCOMING DROP INVERT MEASUREMENT IS LOWER THAN OUTGOING INVERT. THIS IS CONFIRMED AND MOST LIKELY DUE TO THE BOTTOM OF THE PIPE HAVING MULTIPLE FRACTURES WHICH WOULD MAKE THE BOTTOM EDGE OF THE PIPE**

Fracture multiple in I6.

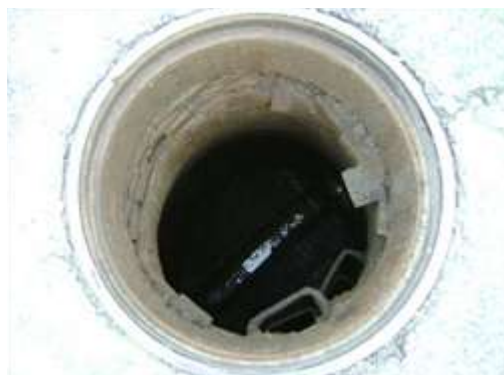
Defect 2

Frame Offset: **1** (in.) Condition: ☐ Sound ☐ Cracked ☒ **Leaks**

Offset Frame

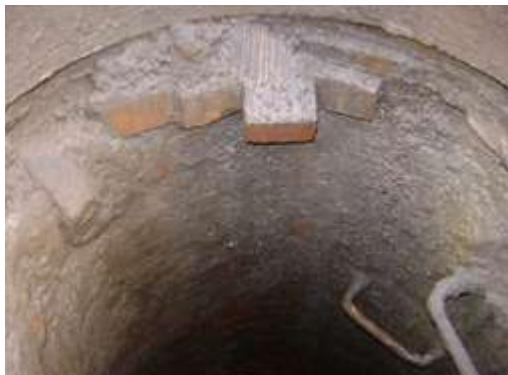
Defect 1

Condition: ☐ Sound ☐ Cracked ☐ Root Intrusion ☒ **Loose Brick** ☒ **Deteriorated**

Infiltration: ☐ None ☒ **Joint** ☐ Cracks ☒ **Mortar** ☐ Roots ☒ **Wall**

Loose brick in chimney

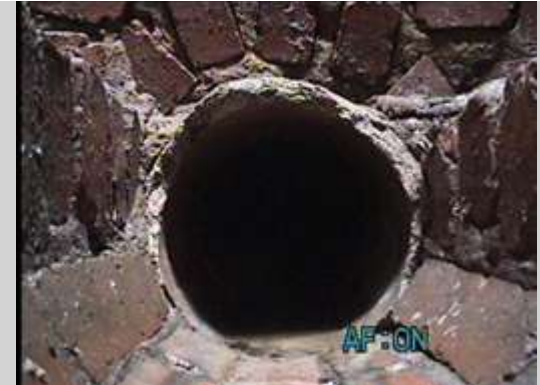
12 O'Clock Outflow

Pipe Height: **8.4** (in.) Rod and Bar (Angled)
Pipe Material: **Clay** ☐ Pipe Lined
Invert Depth: **9.79** (ft.) Flow Characteristics: **Slow**
Deposits: ☒ None ☐ Mud ☐ Sludge ☐ Debris ☐ Grease
Silt Depth: (in.) Deposits Extent:
Infiltration: **None** Pipe Seal Cond: **Cracked**

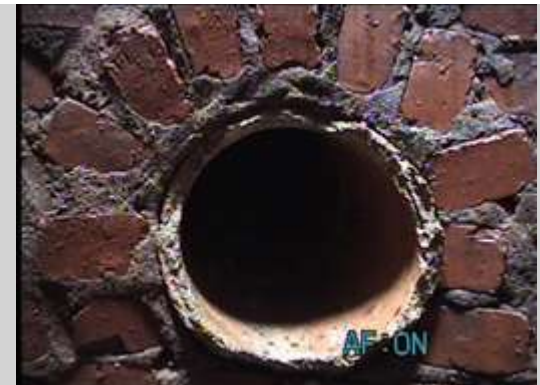
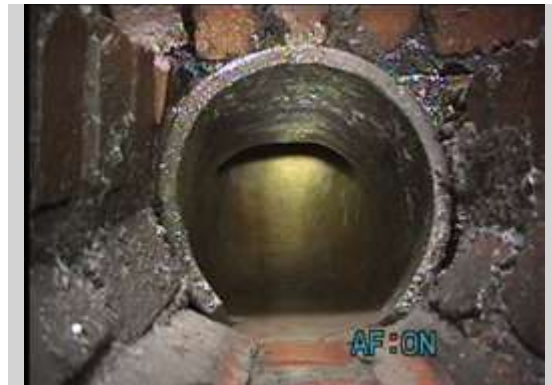
6 O'Clock Inflow

Broken pipe 5:00-7:00 I6.

Drop: **Outside** Rod and Bar
Angled: **Yes** Reading: **8.83** (ft.)
Inv Depth: **9.83** (ft.)
